GROUP Chassis	MODEL 2009-2010MY Rio (JB)
	NUMBER CHA 030	DATE October 2010
TECHNICAL SERVICE BULLETIN		
SUBJECT: RIO (JB) REAR STRUT NOISE REPAIR

SUBJECT:**RIO (JB) REAR STRUT NOISE REPAIR****Service Procedure:**

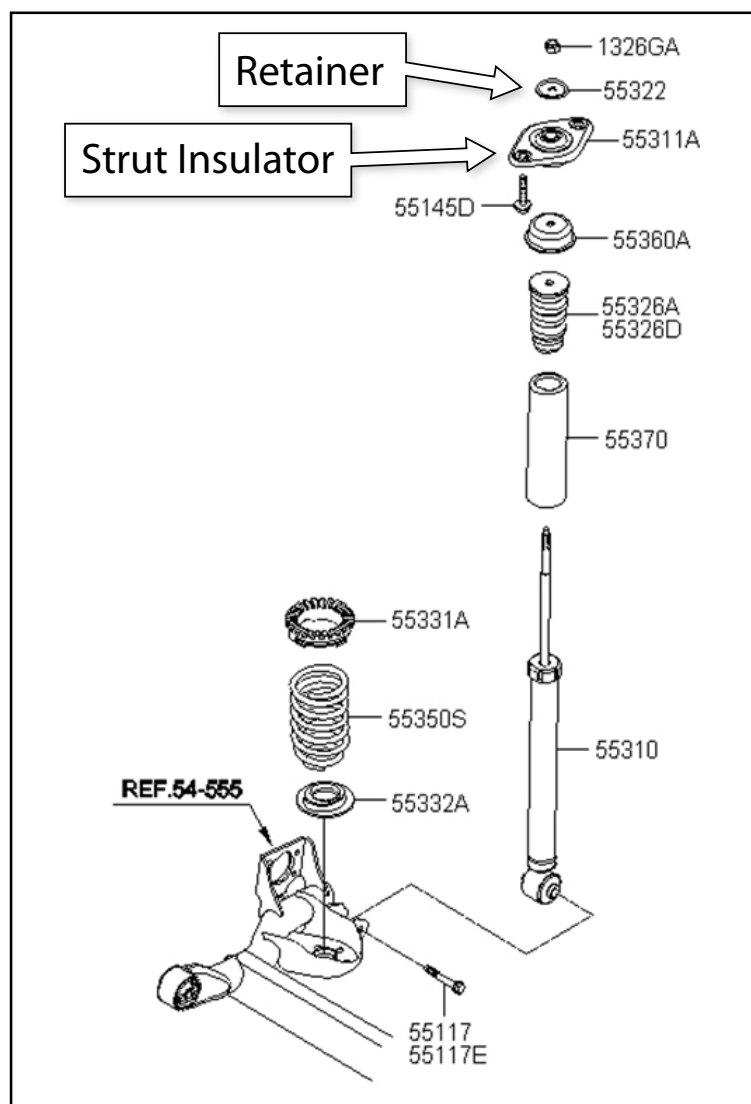
Rio (JB) Rear Strut Assembly

This bulletin provides information relating to Some RIO (JB) vehicles produced from July 1, 2008 to January 27, 2010 that may experience a creaking noise emanating from the rear strut when driving on a rough road in winter weather. To remedy this condition, replace the Rear Strut Insulator and Retainer with improved parts as indicated in the required parts section.

For vehicles with symptom/condition mentioned above; replace the Rear Strut Insulator and Retainer with the improved version according to the applicable workshop manual procedure.
